Home Inspection Report

West Salem Restoration

1492

Columbus St

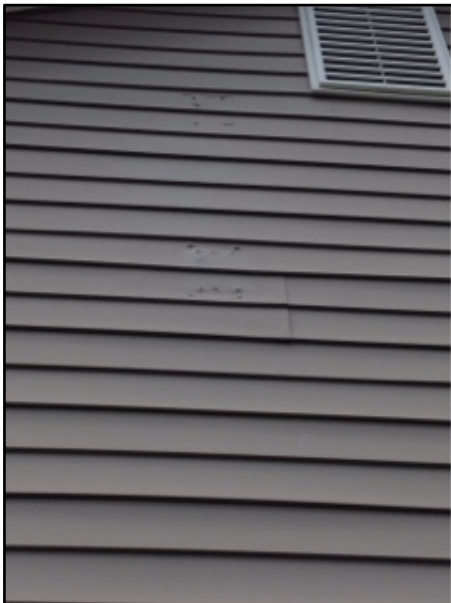
Figure 1-1

Comment 1:
Holes in siding.

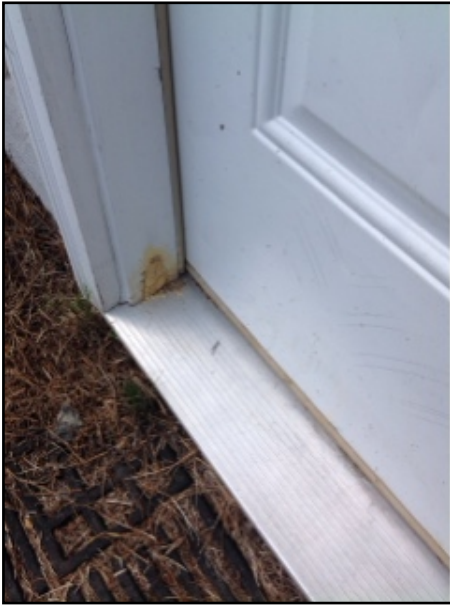
Figure 2-1

Comment 2:
Rot present on side entry door.

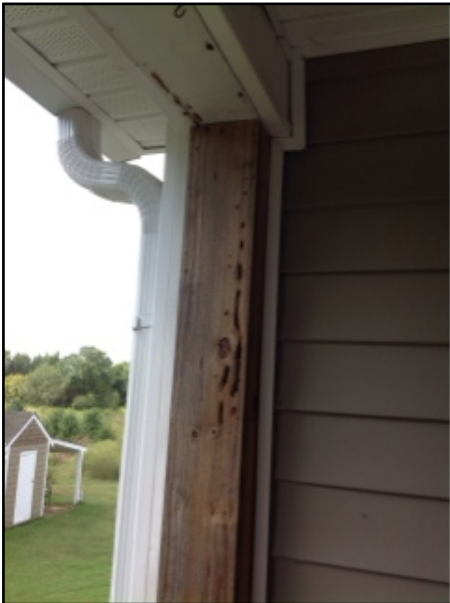
Figure 3-1

Comment 3:
Pests have eaten into wood railing
Need Professional licensed contractor to evaluate.

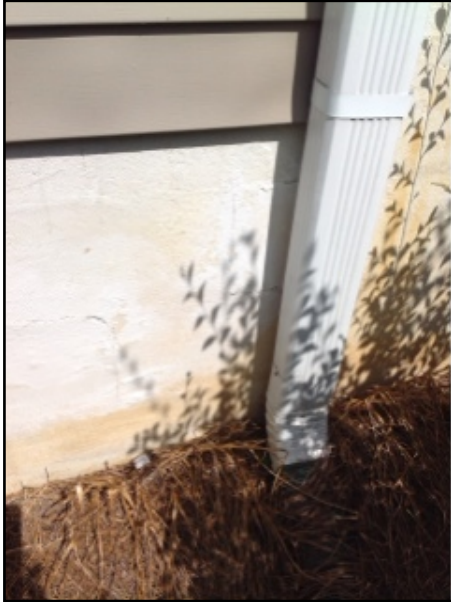
Figure 4-1

Comment 4:
Some cracks in foundation
Recommend licensed contractor evaluate.

Foundation Types:	Crawl Space
Foundation Material:	Concrete Block Condition: Cracks present recommend licensed contractor inspect entire foundation

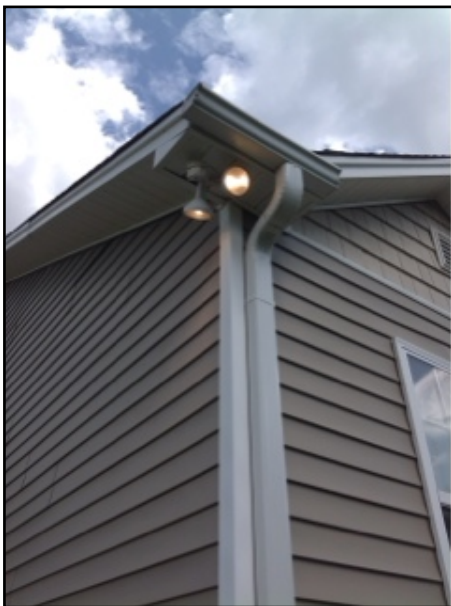
Figure 5-1

Comment 5:
Motion light staying on
Recommend licensed electrician further evaluate.

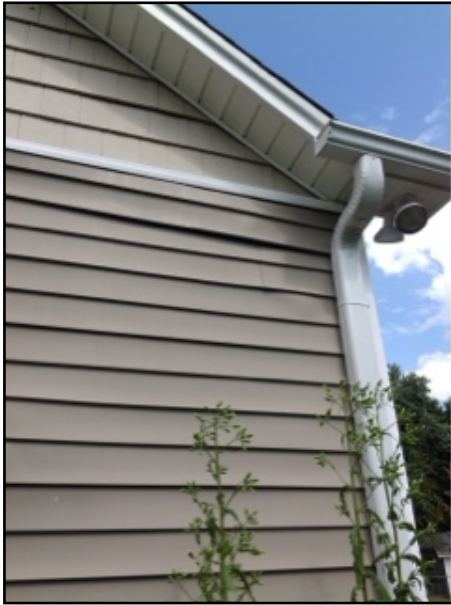
Figure 6-1

Comment 6:
Loose siding.

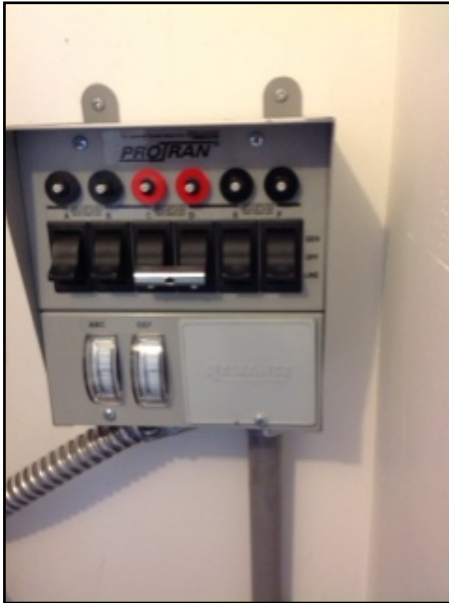
Figure 7-1

Comment 7:
Generator sub panel.

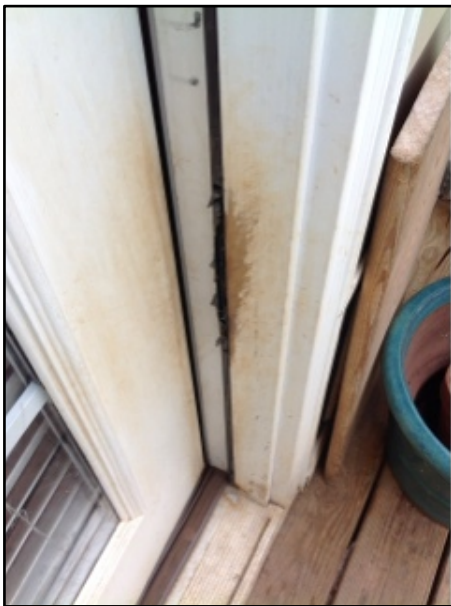
Figure 8-1

Floors:	Tile, Wood Condition: Satisfactory
Walls:	Painted Drywall Condition: Satisfactory
Window Types:	Single Hung Condition: Satisfactory
Window Materials:	Vinyl
Entry Door Types:	Hinged Condition: Weather stripping torn on rear door
Entry Door Materials:	
Interior Door Materials:	
Fireplace:

Comment 8:
Torn weatherstripping.

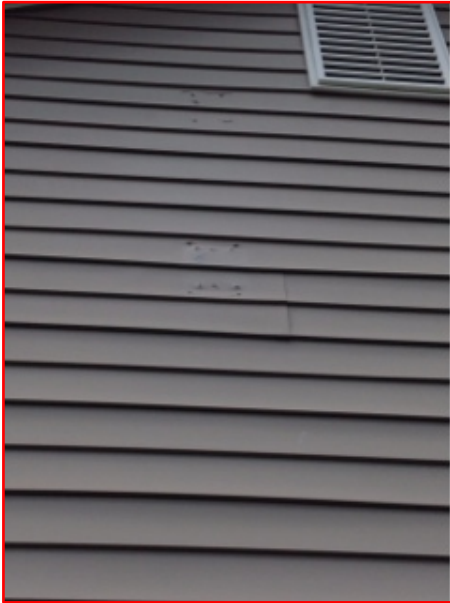
Figure 1-1

1) Holes in siding.

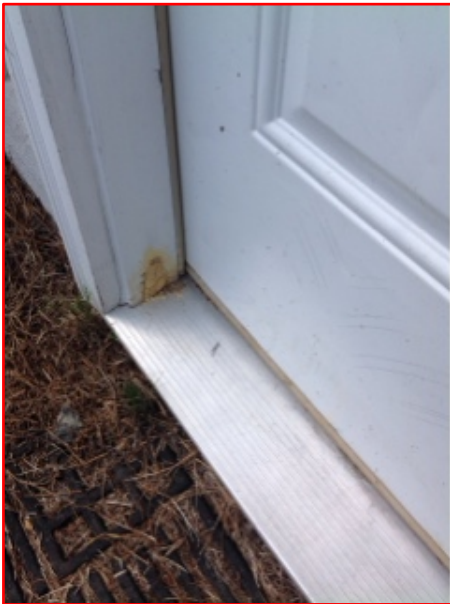
Figure 2-1

2) Rot present on side entry door.

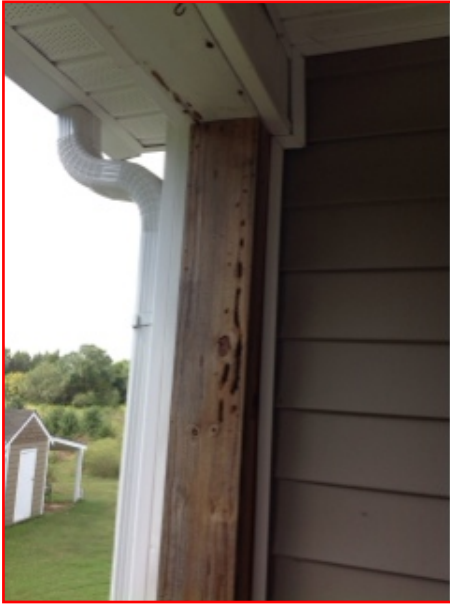
Figure 3-1

3) Pests have eaten into wood railing
Need Professional licensed contractor to evaluate.

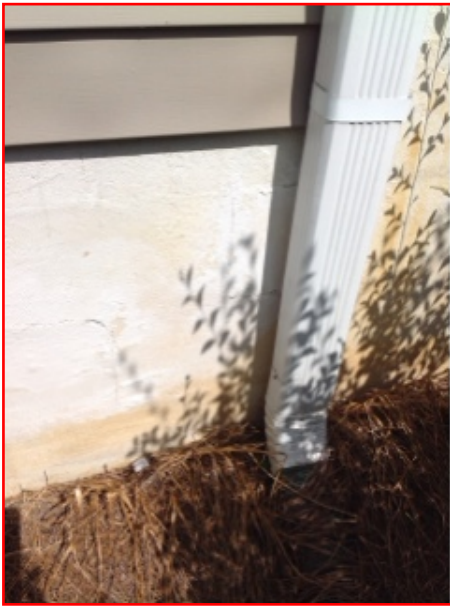
Figure 4-1

4) Some cracks in foundation
Recommend licensed contractor evaluate.

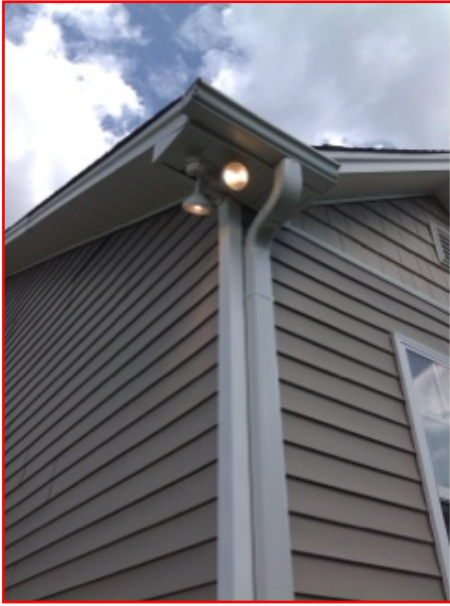
Figure 5-1

5) Motion light staying on
Recommend licensed electrician further evaluate.

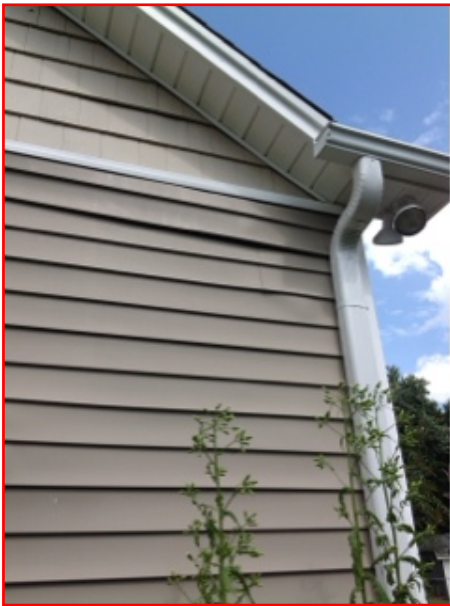
Figure 6-1

6) Loose siding.

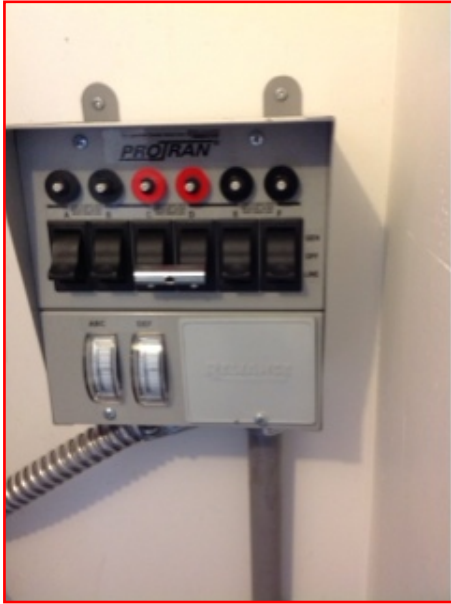
Figure 7-1

7) Generator sub panel.

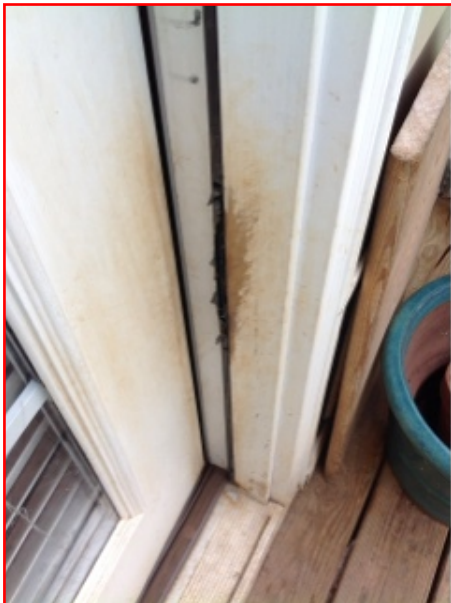
Figure 8-1

8) Torn weatherstripping.
